Paris Branch
Recreational Use Attainability Analysis

March 2005

Prepared by:
MEC WATER RESOURCES, INC.
1000 North College Avenue, Suite 4
Columbia, Missouri 65201

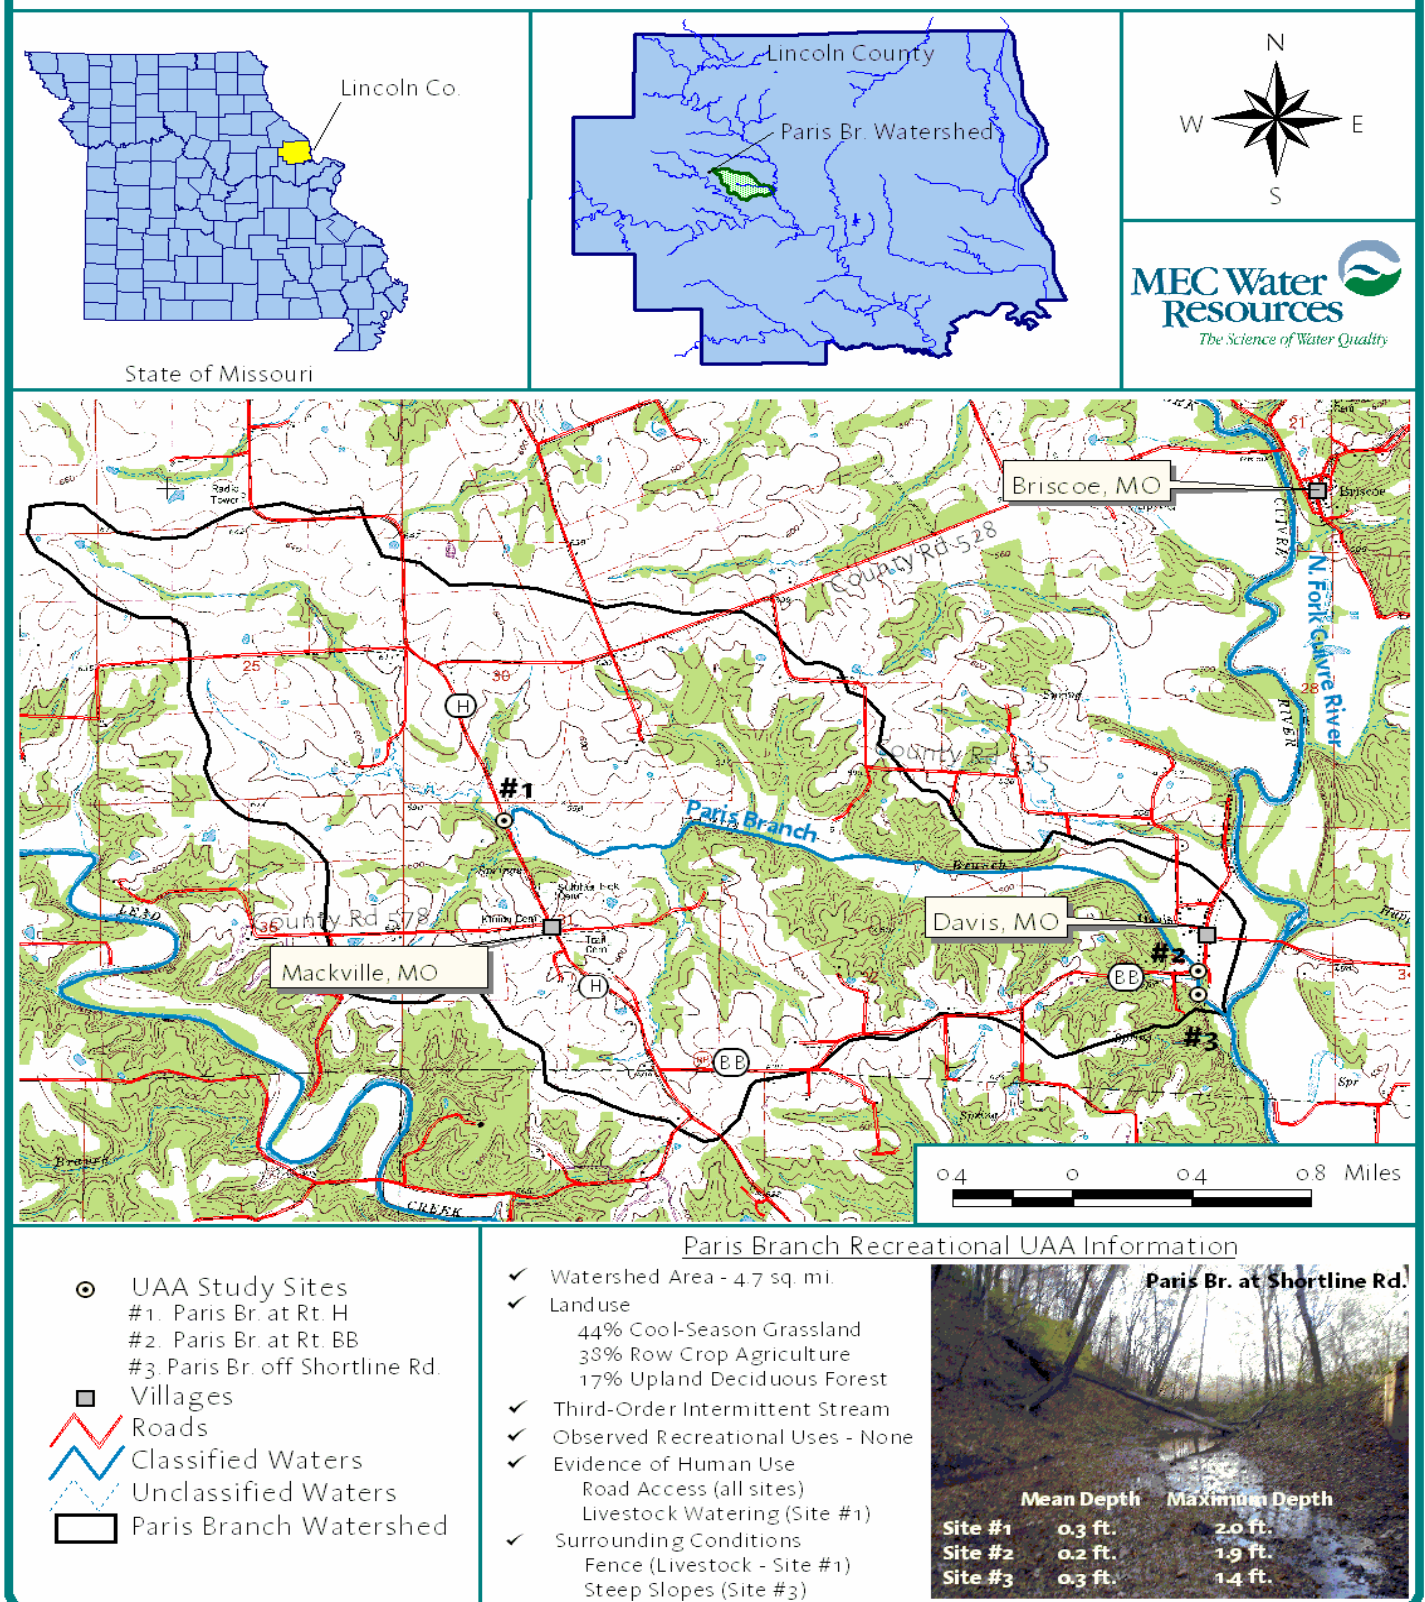
Figure 1. Paris Branch UAA Study Area and Sites

A three mile segment of Paris Branch (Figure 1) is a Class C water of the state and a 3rd order tributary to the North Fork Cuivre River (Cook 2000). Uses currently designated for Paris Branch include: Protection of Warm-Water Aquatic Life, Livestock and Wildlife Watering, Human Health Fish Consumption, and Secondary Contact Recreation. Draining a 4.7 mi.² watershed in west-central Lincoln County, Paris Branch is predominated by cool season grassland (44%), row-crop agriculture (38%), and upland deciduous forest (17%) according to 1993 Thematic Mapper imagery. The Paris Branch watershed is contained within the Cuivre River Basin (8 digit HUC 07110008) and State assigned water body identification number is 0176.

Three sites (Figure 1) within classified sections of Paris Branch were assessed on October 25, 2004 using methods described in section IV; Route H bridge (39.0672, -91.06424), Route BB bridge (39.0556, -91.02025), and the Shortline Road access (39.0545, -91.0197). Surveys were conducted during baseflow conditions as evidenced by precipitation data from USGS gage station 05514500 Cuivre River near Troy, MO and streamflow measurements taken in Paris Branch the day of the survey (Tables 1 & 2). Hydrologic conditions observed during the survey are believed representative due to a relatively small watershed area (4.7 mi.²) that limits periods of sustained baseflow, and the definition of Class C waters provided in State regulations.

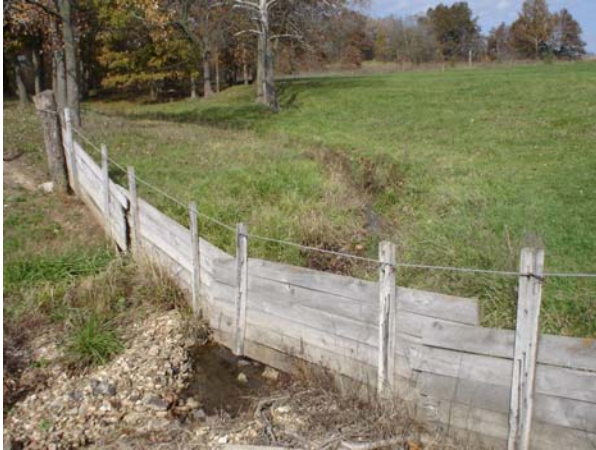
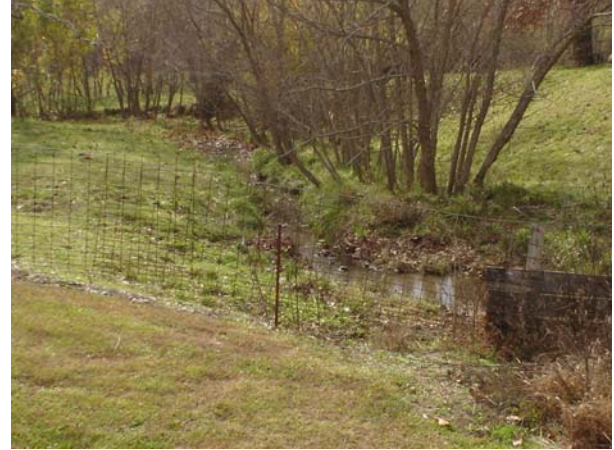
Figure 2. Paris Br. at Rt. H (Downstream View) Figure 3. Paris Br. at Rt. H (Upstream View)

The landscape near the Highway H bridge crossing is an open grazing pasture with a fence (Figure 2) across the stream channel. Livestock were observed grazing near the stream during the survey. Banks are gently sloping and are vegetated with grasses and forbs (Figure 3). Riparian areas are composed of cool-season grasses associated with the grazing pasture. Channel substrate was a mud and clay mixture. Limited algae deposits within pooled reaches may deter human use.

Mean depth along a 120 ft. assessment reach was 0.3 ft as determined from fifteen transects (Appendix B). The maximum depth observed at this location was 2.0 feet in a small pool upstream of the road access. There was no visible flow within the stream channel.

Livestock watering was the only observed or evidenced human use at this site. Fences impede public access to much of the assessment reach. No individuals were seen or found to be available for interviews near the Route H bridge during the survey.

MEC staff believe that Whole Body Contact Recreation (WBCR) is neither an existing or an attainable use at this site based on limited access to the stream imposed by fences, absence of observed recreational uses, and low flow shallow conditions.

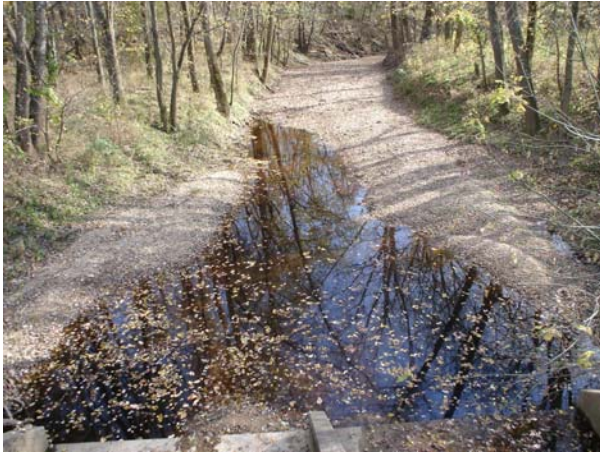
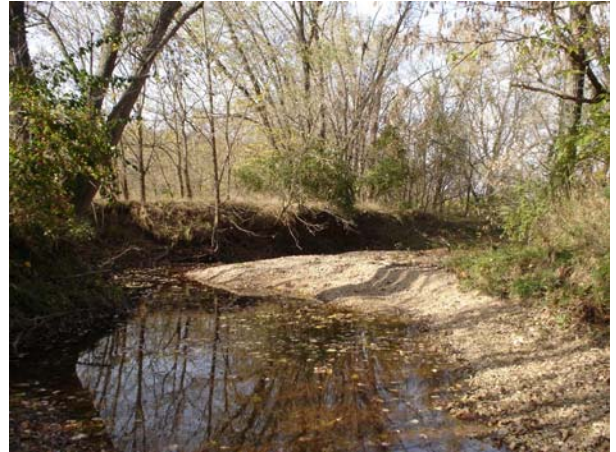
Figure 4. Paris Br. at Rt. BB (Downstream View)

The road crossing at Route BB is located near the small village of Davis, MO. Stream banks near the road are gently sloping and relatively easy to access (Figures 4 & 5). Riparian areas are wide and open and primarily vegetated by the upland deciduous forest complex. The stream channel was observed to be a mixture of cobble and sand. Mean depth along a 600 ft. assessment reach was 0.2 ft as determined from eight transects (Appendix B). The maximum depth observed at this location was 1.9 feet in a small pool downstream of the road access. There was no visible flow within the stream channel.

There were no observed or evidenced human uses at this site. No individuals were seen or found to be available for interviews near the Route BB bridge or the village of Davis during the survey. MEC staff believe that WBCR is neither an existing or an attainable use at this site based on absence of observed recreational uses and low flow shallow conditions.

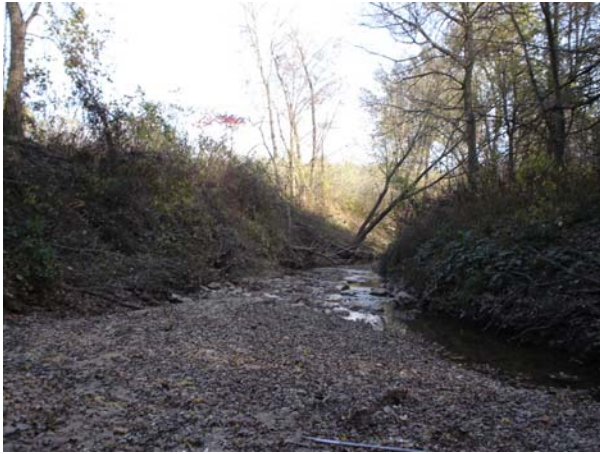
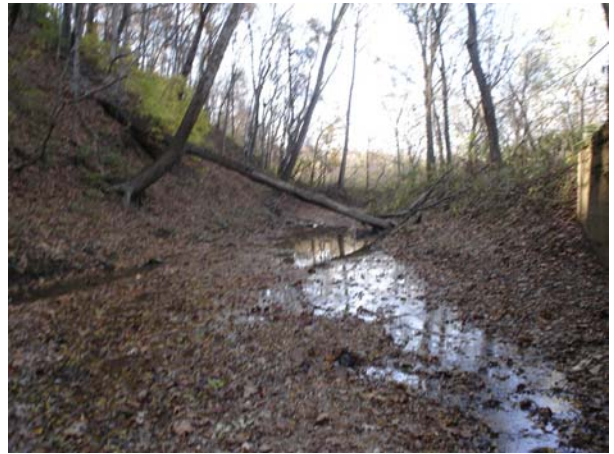
Figure 6. Paris Br. at Shortline (Downstream View) Figure 7. Paris Br. at Shortline (Upstream View)

Shortline Road is a small gravel road off Route BB that leads up to a private drive near the confluence of Paris branch and the North Fork Cuivre River. Stream banks are steep, sparsely vegetated, and covered with rocks and brush (Figures 6 & 7). Riparian area is greater than 100 feet wide on both sides of the stream and consists of large, mature trees. Stream substrate was approximately 80% cobble, 10% sand, and 10% silt.

Mean depth along a 500 ft. assessment reach was 0.3 ft as determined from seventeen transects (Appendix B). The maximum depth observed at this location was 1.4 feet in a small pool upstream of the road access. Observed streamflow was 0.42 cfs and a mean velocity of 0.38 fps.

There were no observed or evidenced human uses at this site. No individuals were seen or found to be available for interviews near the Shortline Rd. access during the survey. MEC staff believe that WBCR is neither an existing or an attainable use at this site based on absence of observed recreational uses and low flow shallow conditions.
